Trayed Column – Entrainment

Entrainment - Jet Flooding in a Trayed Column

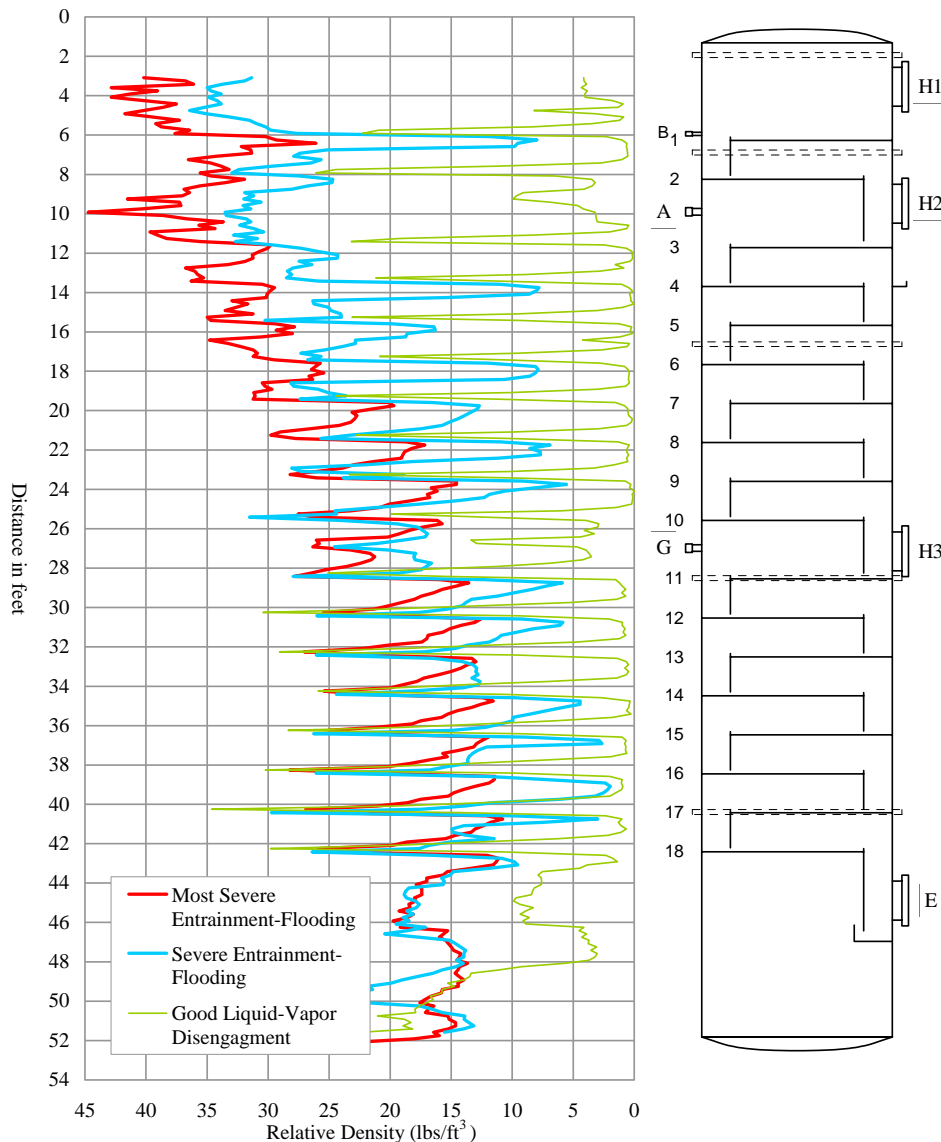
TowerScan Results: The first scan (plotted in red) revealed the trays to be severely entrained and in a "jet" flood. In addition, the base liquid level appeared was highly aerated and above the vapor inlet, almost reaching the bottom tray. As changes were made to the tower's operating conditions, especially the reboiler and base liquid level, the process personnel were able to eliminate the entrainment (green plot) until the tower was operating in a stable manner at the "new post turnaround normal conditions" and the product was on specification.
