Packed Bed Tower - Baseline Scans Used for Shutdown Planning

Phone (888) 724 - 1798
 Packed Beds: Baseline Scans Used for Shutdown Planning 2 Years Later

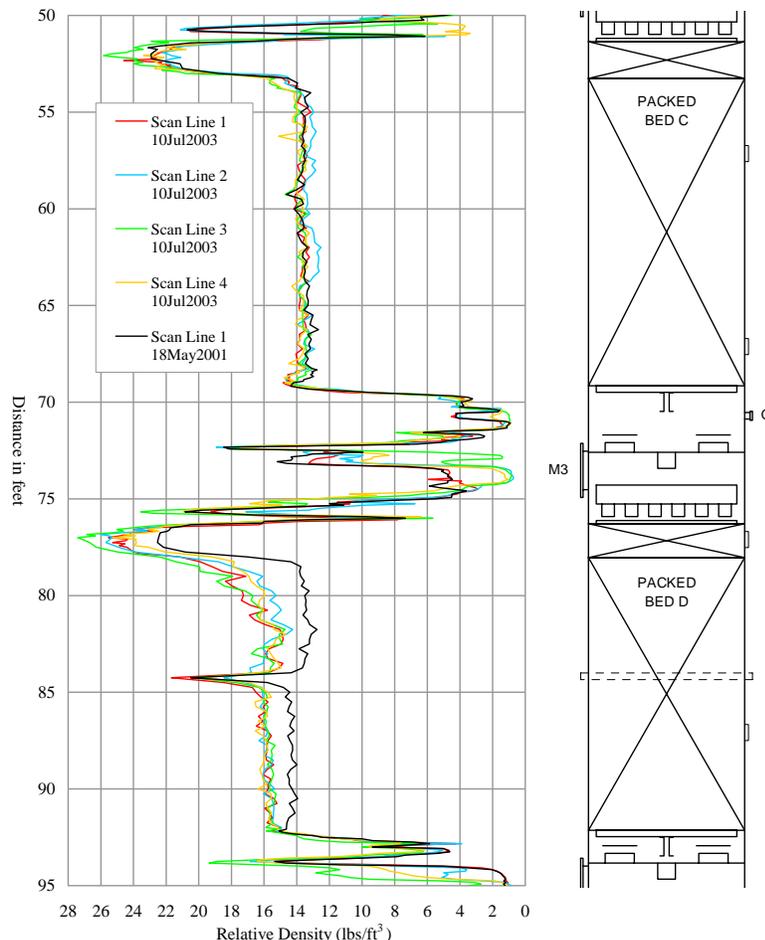
TowerScan Results: The adjoining scan profile shows the grid scan performed two years after the baseline scan, as well the profile (black) for one of the four baseline profiles. Each of the six packed beds consisted of a shorter section of structured packing in the top of the bed, with the majority of the bed consisting of dumped packing.

The greatest contrast was between the two beds shown, beds C and D. While all of the beds showed some fouling in the smaller structured packing element at the top, the remainder of the beds, consisting of the dumped packing, were seen to be still operating with a uniform density profile, clear of significant fouling. The exception was bed D below the feed inlet, which showed appreciable fouling throughout the bed. Armed with this knowledge going into the shutdown, the unit engineer was able to minimize the downtime by planning to clean the distributor above each bed, as well as the top structured packing element, while leaving in place all of the dumped packing except for that in bed D which was replaced.
